Manhole Inspection Summary

Manhole # S41W1_013MH

Insp Date: **11/30/07 12:50 PM**

Location Address: **3501 7th Street**

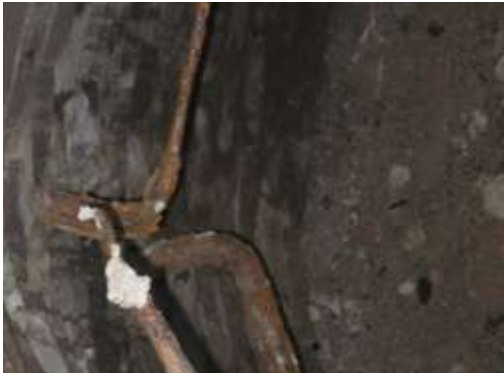
Defect 2

Steps Count: **3** Missing: **0** ☒ **Corroded**

corrosion on steps

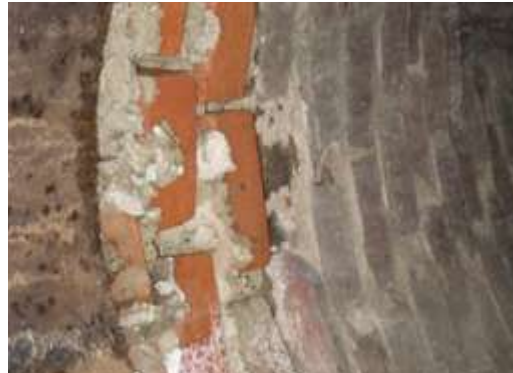
Defect 1

Condition: ☐ Sound ☐ Cracked ☐ Root Intrusion ☒ **Loose Brick** ☐ Deteriorated

Infiltration: ☐ None ☐ Joint ☐ Cracks ☒ **Mortar** ☐ Roots ☐ Wall

mortar on chimney

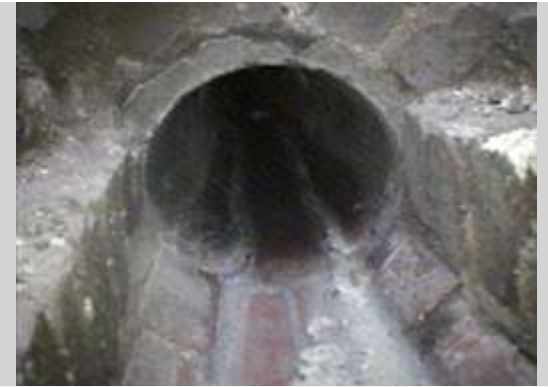
12 O'Clock Outflow

8 in. Circular Gravity Sewer
Pipe Out @ 12 O'Clock

Pipe Height: **7.2** (in.) Rod and Bar (Angled)
Pipe Material: **Clay** ☐ Pipe Lined
Invert Depth: **7.46** (ft.) Flow Characteristics: **Fast**
Deposits: ☒ None ☐ Mud ☐ Sludge ☐ Debris ☐ Grease
Silt Depth: (in.) Deposits Extent:
Infiltration: **None** Pipe Seal Cond: **Sound**

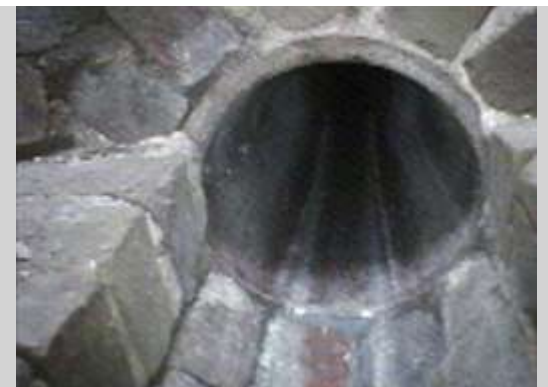
3 O'Clock Inflow

8 in. Circular Gravity Sewer
Pipe In @ 3 O'Clock

Pipe Height: **8.4** (in.) Rod and Bar (Angled)
Pipe Material: **Clay** ☐ Pipe Lined
Invert Depth: **7.16** (ft.) Flow Characteristics: **Fast**
Deposits: ☒ None ☐ Mud ☐ Sludge ☐ Debris ☐ Grease
Silt Depth: (in.) Deposits Extent:
Infiltration: **None** Pipe Seal Cond: **Sound**
